INVESTIGATION OF COMPOSITE COATING
SYSTEMS FOR RAIN-EROSION PROTECTION

Florida Atlantic University

Naval Air Systems Command

15 July 1974

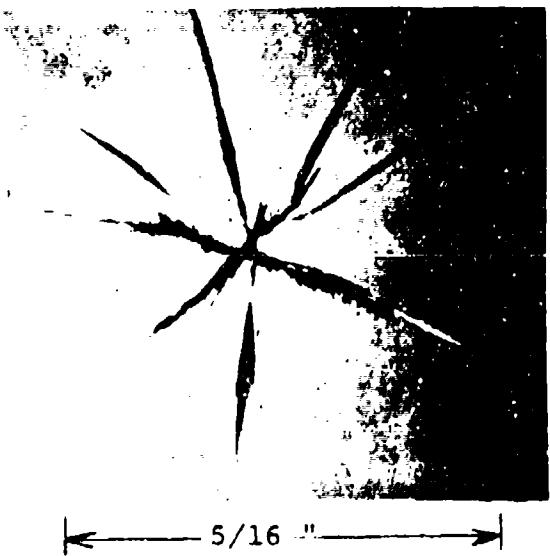
B. MAGNIFIED VIEW OF STAR CRACK FORMED

FIGURE 15. CRACK PRODUCTION UNDER FLEXURE PRODUCED BY
NYLON-SPHERE IMPACT
